Greenfield Engineering & Planning MEMORANDUM

To: Traffic Safety Committee
From: Glen Morrow, City Engineer
Date: October 31, 2025
Re: Evaluation for 1600 block of Melody Lane

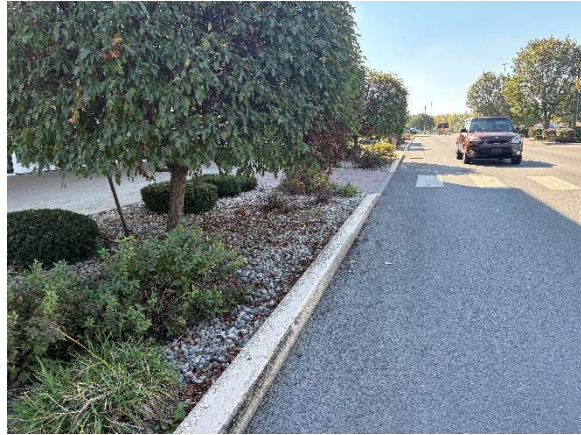
Landscaping: most of the landscaping trees and bushes along the building appear to be in the public right-of-way and the landscaped parking lot islands appear to be on private property. Landscaping from both sides does appear to be blocking sight-distances. Viewing from a small car is difficult to exit the perpendicular drive aisles and it is difficult in both large and small vehicles to see pedestrians walking out of businesses.

Section 155.063 3. G of the City Unified Development Ordinance states that *Landscaping materials between 3 and 10 feet in height at maturity shall not be located within the right of way Clear Sight Triangle.* 5.069. As measured from the pavement, the shrubs in the parking lot islands are as high as 4 feet and the trees along the building block sight as low as 3 feet. In discussions with the City Planning Director, the shrubs could be replaced with lower spreading varieties to reduce the maintenance needs, or more regularly scheduled maintenance would need to occur on existing shrubs to keep them below 3 feet. The trees could be trimmed higher or replaced with other species that provide more open space. This may need the opinion of an arborist to determine if removing the limbs to the height needed would likely kill the tree, at which point replacement may be more efficient.

6. Work with Owner to seek City permission to remove trees on the east side of the right-of-way (within the right-of-way).
7. Require Owner to trim trees on the west side of the right-of-way (on private property) to ensure limbs do not encroach the 10-foot clear view. If consultation with an arborist indicates the limbing may kill the trees, consider replacement with another tree species.

8. Request Owner to replace shrubs on the west side of the right-of-way with low spreading shrubs or require Owner to trim shrubs below 3-foot.
