Greenfield Engineering & Planning MEMORANDUM

To: Traffic Safety Committee
From: Glen Morrow, City Engineer
Date: October 31, 2025
Re: Evaluation for 1600 block of Melody Lane

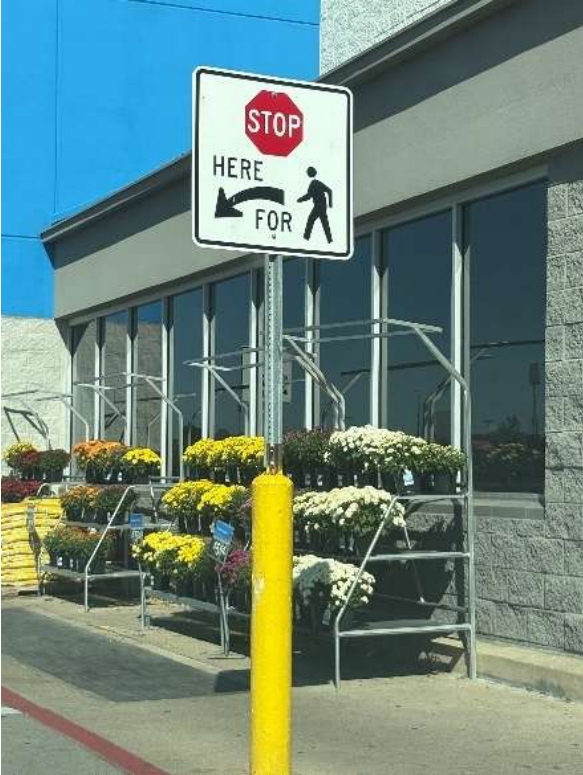
Kroger's (looking south)

It should also be noted that the “Stop Here for Pedestrian” signs at Wal-Mart are MUTCD compliant signs (R1-5b). There are other signs that are placed at crosswalks in the middle of the street, but they do create problems with snow fighting operations.
